CAPTAIN'S REPORT

TUG MACKENZIE ROSE INCIDENT

In the Matter of COEYMANS MARINE TOWING, LLC d/b/a CARVER MARINE TOWING as Owner and Operator of M/T MACKENZIE ROSE, (IMO No. 8968765), her cargo, engines, boilers, tackle, equipment, apparel, and appurtenances, etc., IN REM, ("M/T MACKENZIE ROSE"), petitioning for exoneration from or limitation of liability in allision with Norfolk and Portsmouth Belt Line Railroad Company Main Line Railroad Bridge (the "Bridge") occurring June 15, 2024 in and about the Elizabeth River, Virginia.

July 2, 2025

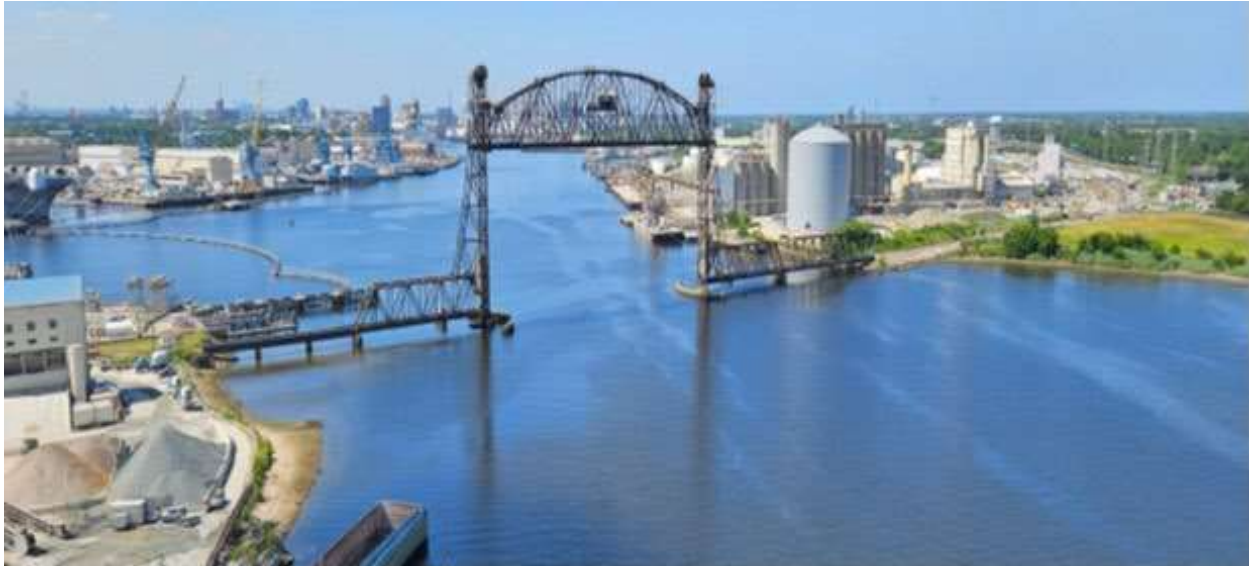
The Norfolk and Portsmouth Belt Line Railroad Company Main Line Railroad Bridge (NPBL Bridge) is in an open position.

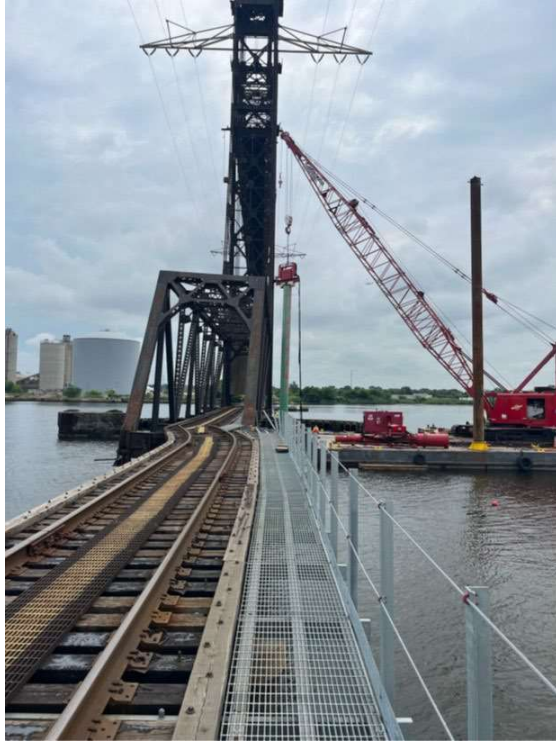
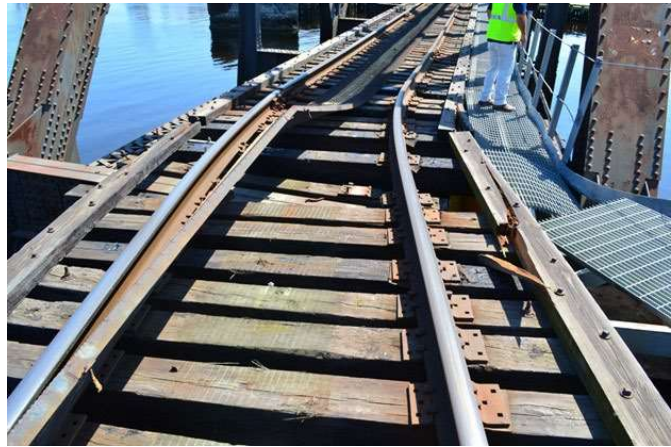
NPBL Bridge damage on June 15, 2024

1. The unit made direct contact with the bridge, causing visible structural movement (as evidenced by surveillance video), which is contrary to crew statements of “no damage” or “minor impact.”

Despite crew claims of minimal impact, photographs, and video of bridge structure movement document otherwise. Variance in post-incident reports and a lack of timely Coast Guard notification further undermine the reliability of the crew's account and created potentially life-threatening conditions for the Norfolk and Portsmouth Belt Line Railroad Company and the public at large.
